# Manhole Inspection Summary

Manhole # S29A\_\_024MH

**Location** Address: **ARGYLE AVE**

Cross Street: **MCCULLOUGH CIR**

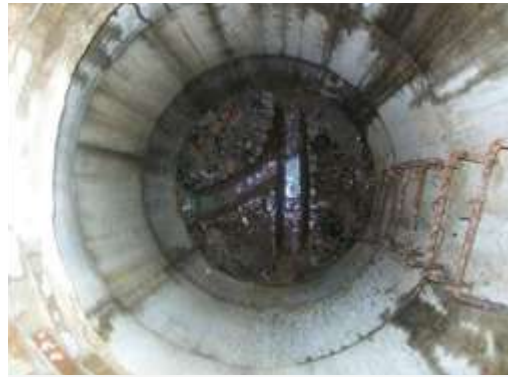
Top View

INFILTRATION AT CHIMNEY/CORBEL JOINT. DEBRIS ON BENCH.

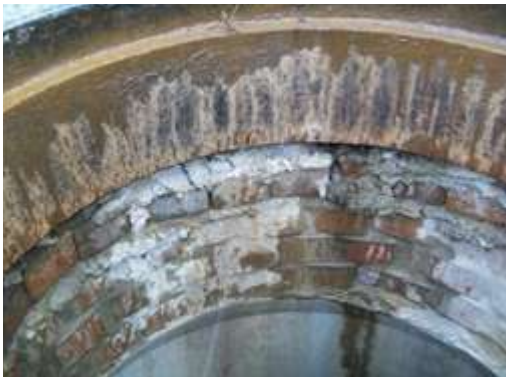
Defect 2

Condition: ☐ Sound ☐ Cracked ☐ Root Intrusion ☒ **Loose Brick** ☒ **Deteriorated**

Infiltration: ☐ None ☒ **Joint** ☐ Cracks ☐ Mortar ☐ Roots ☐ Wall

LOOSE BRICKS AND MISSING MORTAR IN CHIMNEY. EVIDENCE FRAME LEAKS.

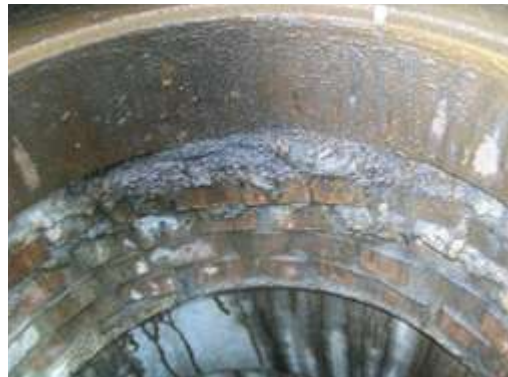
Defect 1

☒ **Leaks**

EVIDENCE FRAME LEAKS, DETERIORATION OF CHIMNEY

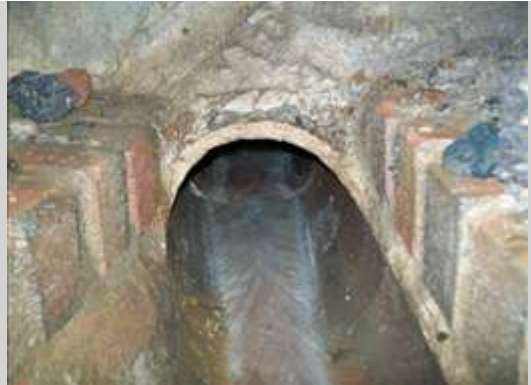
12 O'Clock Outflow

8 in. Circular Gravity Sewer  
Pipe Out @ 12 O'Clock

Pipe Height: (in.) Direct (Angled)  
Pipe Material: **Clay** ☐ Pipe Lined  
Invert Depth: **11.75** (ft.) Flow Characteristics: **Slow**  
Deposits: ☒ None ☐ Mud ☐ Sludge ☐ Debris ☐ Grease  
Silt Depth: (in.) Deposits Extent:  
Infiltration: **None** Pipe Seal Cond: **Sound**

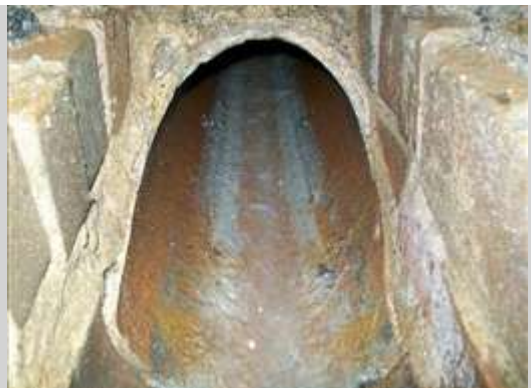
6 O'Clock Inflow

8 in. Circular Gravity Sewer  
Pipe In @ 6 O'Clock

Pipe Height: (in.) Direct  
Pipe Material: **Clay** ☐ Pipe Lined  
Invert Depth: **11.65** (ft.) Flow Characteristics: **Slow**  
Deposits: ☒ None ☐ Mud ☐ Sludge ☐ Debris ☐ Grease  
Silt Depth: (in.) Deposits Extent:  
Infiltration: **None** Pipe Seal Cond: **Sound**

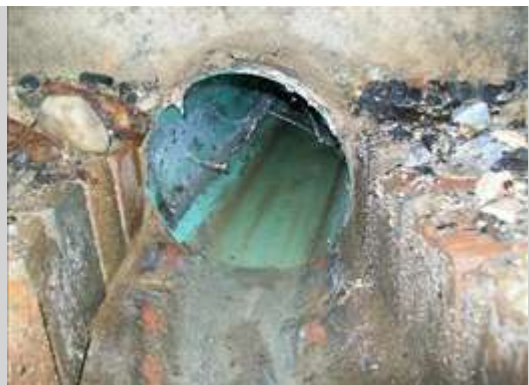
9 O'Clock Inflow

8 in. Circular Gravity Sewer  
Pipe In @ 9 O'Clock

Pipe Material: **PVC** ☐ Pipe Lined

Invert Depth: **11.47** (ft.) Flow Characteristics: **Slow**

Infiltration: **None**

Pipe Seal Cond: **Sound**
